Subject: Department of Natural Resources Washington Geological Survey,
School Seismic Safety Assessment Project, Contract No. AE 410 -
Seismic Evaluation for **Mount Vernon School District**

1. Lincoln Elementary School, Main Building

Mount Vernon, Lincoln Elementary School, Main Building

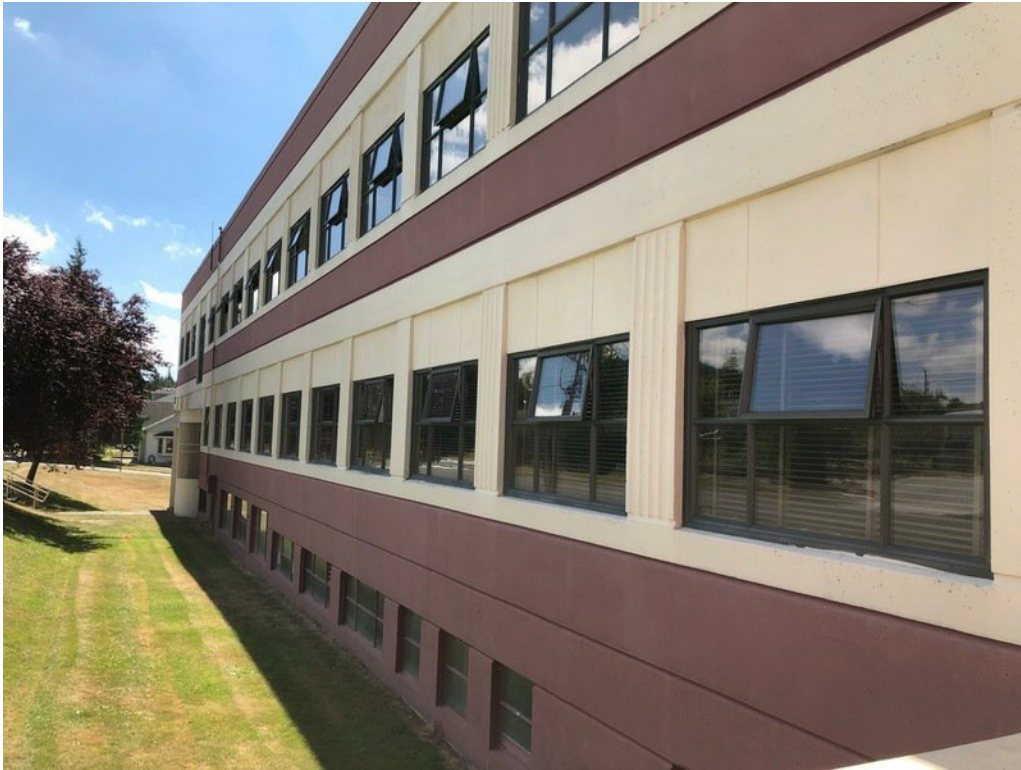
Deficiency	Description
Load Path	1930s-era concrete construction has an unreliable load path through wall piers. Lateral system strengthening or addition of new shear walls may be appropriate to mitigate seismic risk.
Weak Story	The main building appears to be compliant, however, the gymnasium has a first story that is approximately twice as tall as the second story. Due to the year of original construction (1938) it is assumed that weak story effects were not taken into account in the design of the gymnasium. Requires further investigation to determine building behavior. Additional shear walls or bracing may be appropriate to mitigate seismic risk.
Soft Story	The gymnasium at the first floor is open to the second floor. Due to the year of original construction (1938) it is assumed that soft story effects may not have taken into account in the design of the gymnasium. Requires further investigation to determine building behavior. Additional shear walls or bracing may be appropriate to mitigate seismic risk.

Figure 1-1. East elevation concrete wall. Notice short wall piers at lowest level.

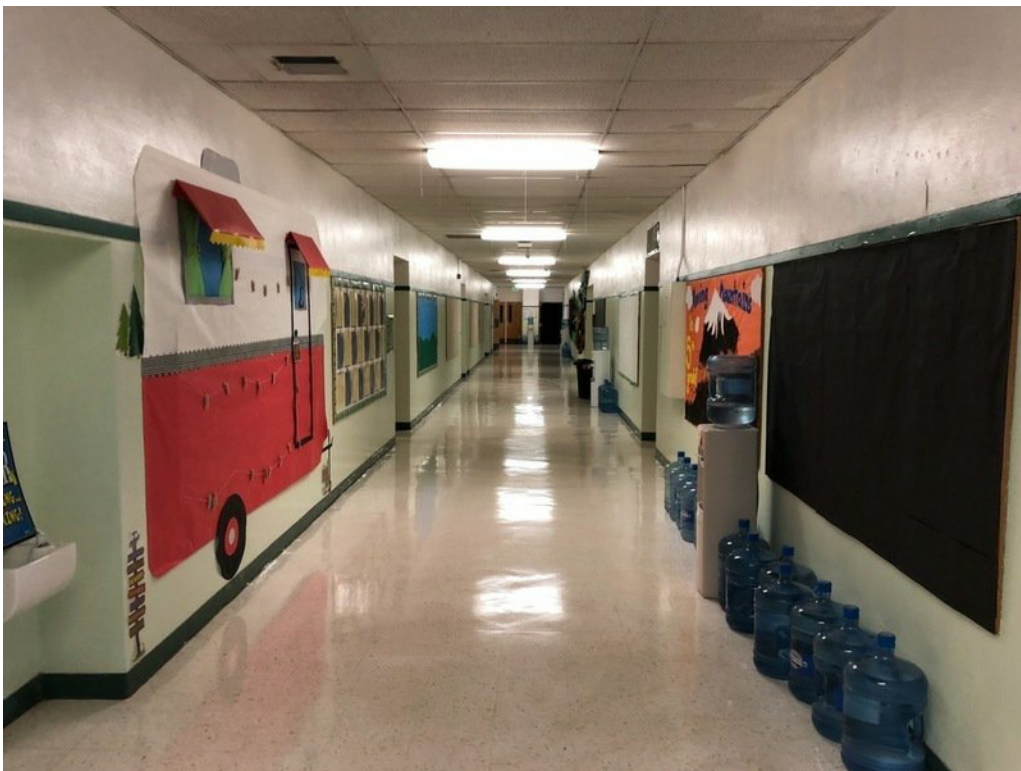
Figure 1-2. Typical interior main central corridor with suspended ceiling.

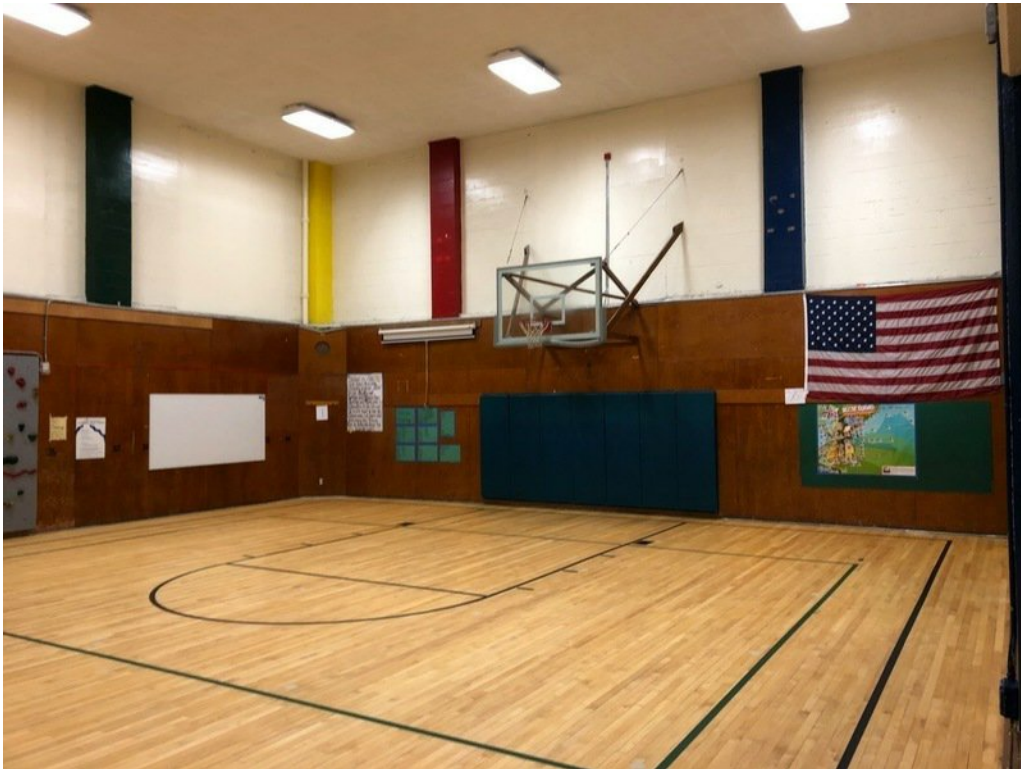
Figure 1-4. Basement level gymnasium with cast-in-place concrete walls and pilasters. The performing arts space is on level 3 above the gym.

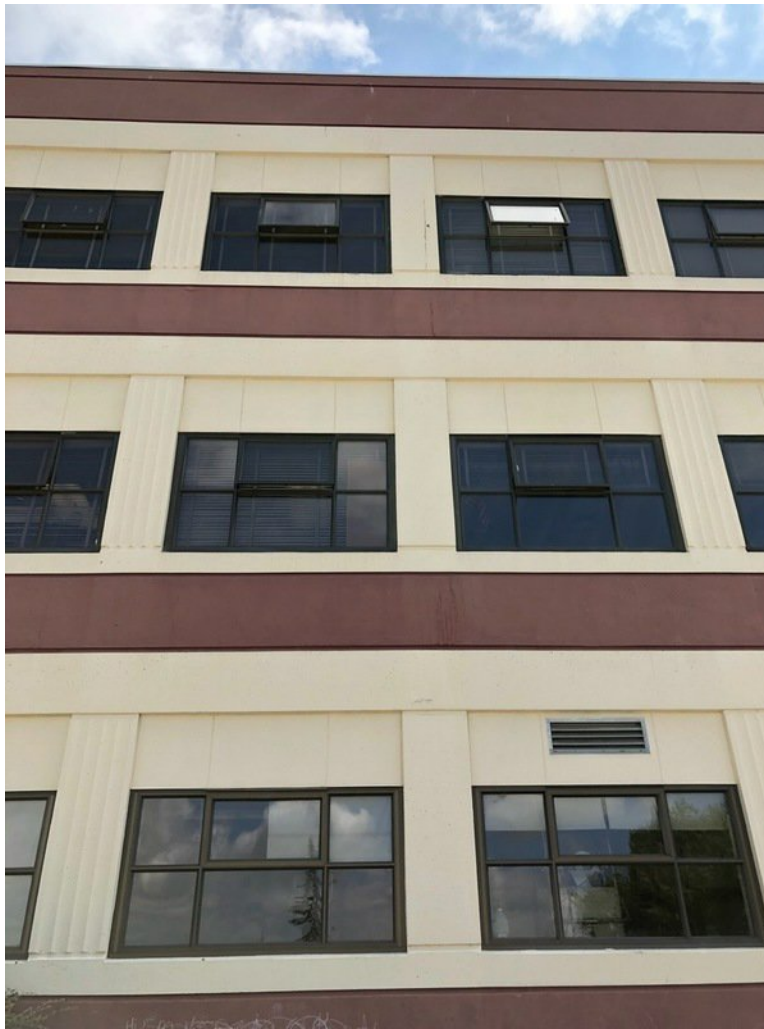
Figure 1-5. Exterior non-ductile concrete wall. Deep spandrel beams and narrow non-ductile concrete wall piers.

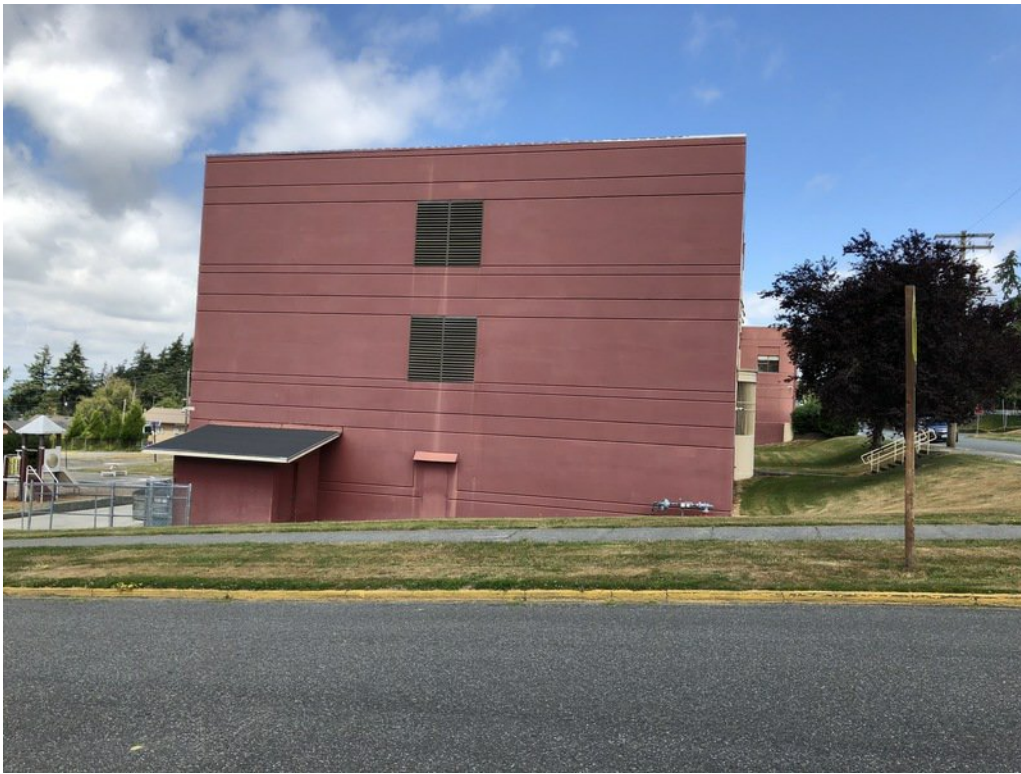
Figure 1-6. Exterior south side of building. Note concrete exterior walls and gently sloping site.

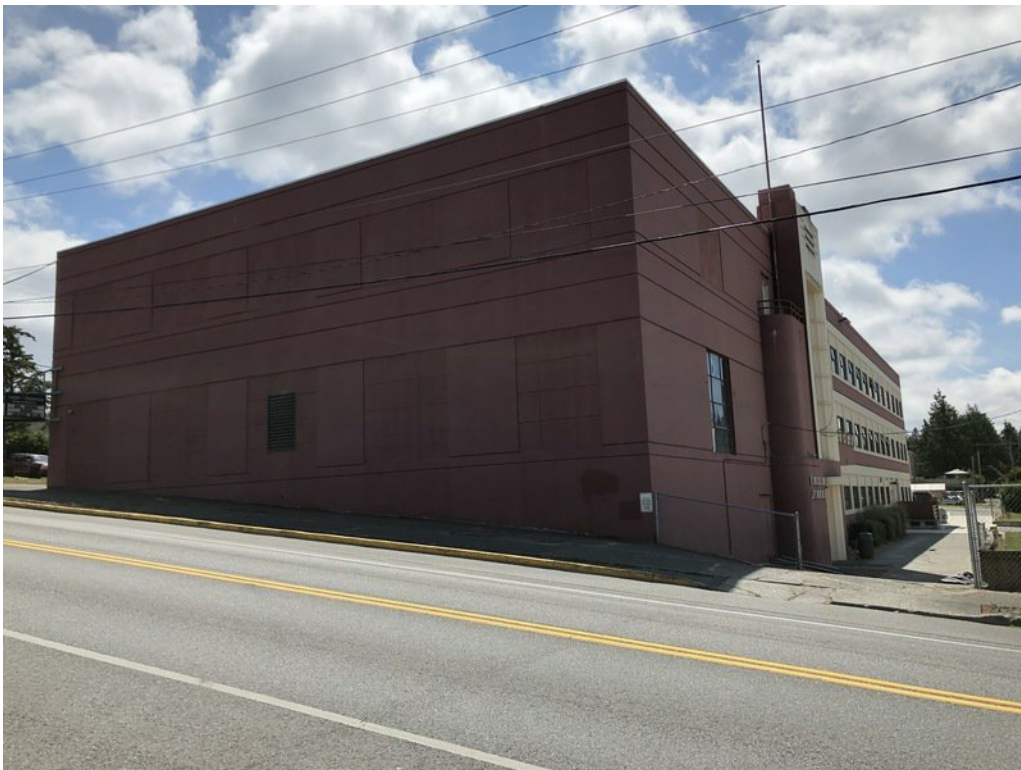
Figure 1-7. Exterior north side of building. Note high bay gymnasium with a performing arts space above the gym.
